# Sample Building Inspection Report

**123 Sample Street, Anywhere, USA 12345**

**Report Number:**

555

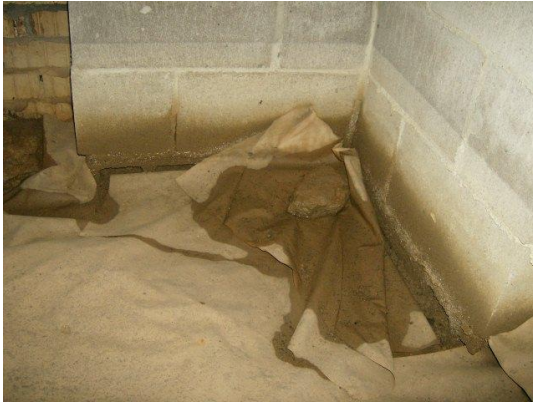
Southwest corner

- **Repair, Monitor:** There is evidence of past water and/or moisture in the crawl space at the southwest corner and near the front of the house. Wet crawl spaces risk building damage from rot and insects and can cause interior mold or mildew. This condition may vary seasonally and/or with precipitation intensity. Roof and lot drainage repairs or improvements should be addressed as a first step to controlling water in the crawl space (see "Roofing"). This condition should then be monitored to determine if additional measures are necessary to protect the building interior from water and moisture damage.

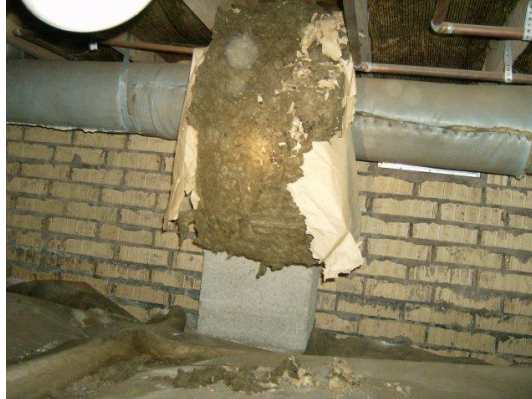
- **Improve:** There is evidence of vermin activity (i.e., droppings near torn insulation batt) in the crawl space. A pest control specialist may need to be consulted for treatment and control advice.

Loose Insulation

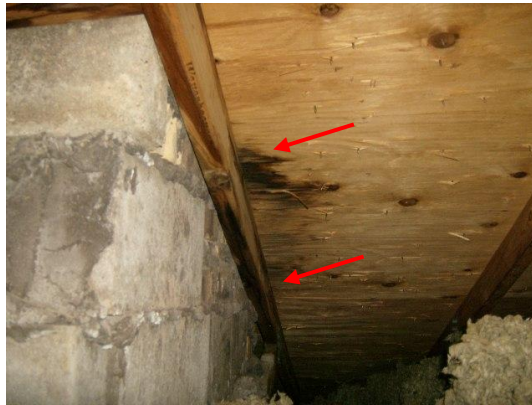
- **Monitor:** Prior leaks to the roofing are evident near the chimney. This would suggest that problems have been experienced in the past. This area should be monitored.

Water Stains near Chimney

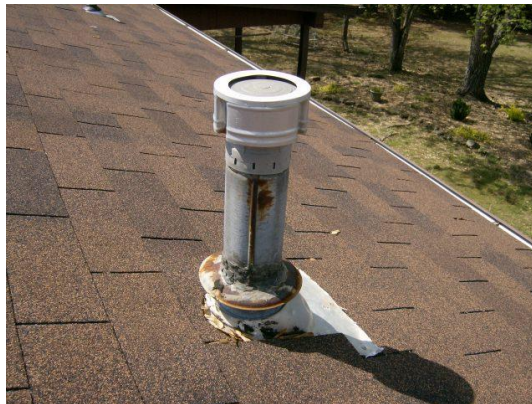
- **Improve:** Some of the metal vents and flashings are rusting. They should be painted to extend the life of the material.

Rusted vent for water heater

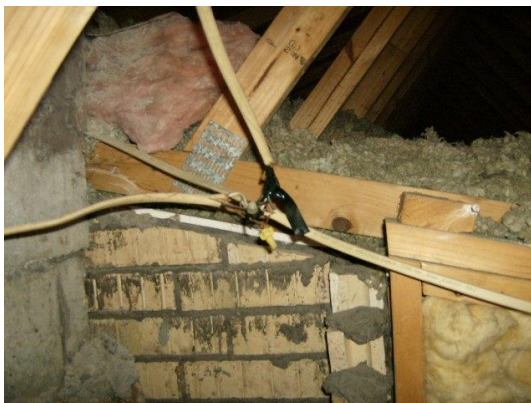
- **Repair:** Improper electrical connections in the attic should be repaired. All electrical connections should be made inside junction boxes fitted with cover plates.

Wire connections near chimney

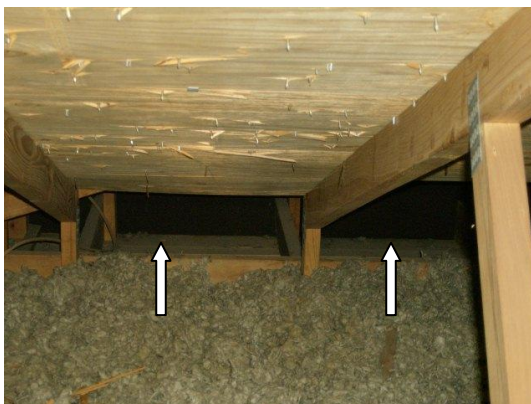
- **Repair:** Insulation could be evened out in some places within the attic.
- **Improve:** The front 2 – 3 foot section of the home (ceiling over bedrooms) should be insulated.

Missing Insulation

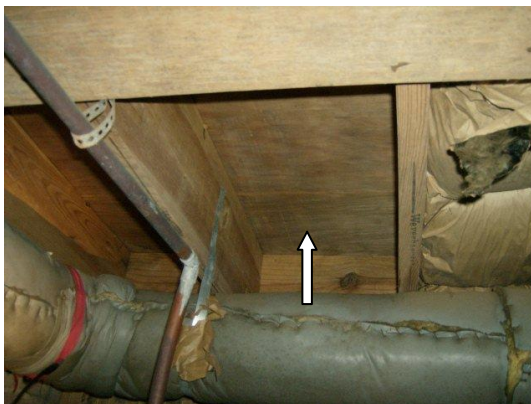
- **Repair:** Loose or missing insulation in the floor above the crawl space should be improved.

Missing Floor Insulation
