# Sample Building Inspection Report

**123 Sample Street, Anywhere, USA 12345**

**Report Number:**

555

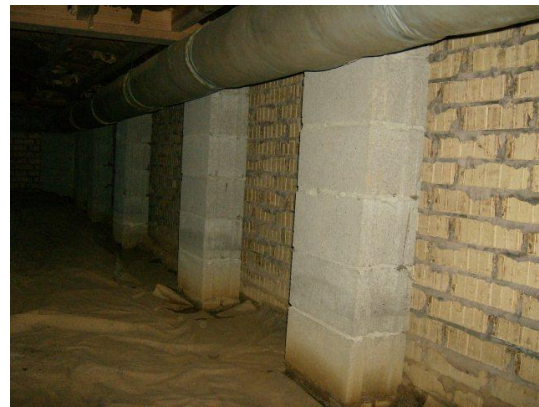
Foundation Wall

The foundation under the fireplace appeared to be in good condition. No cracks or settling was observed. The floor joist near the fireplace foundation has also been doubled to provide greater strength and support. No sagging of the joist(s) in this general area was observed.

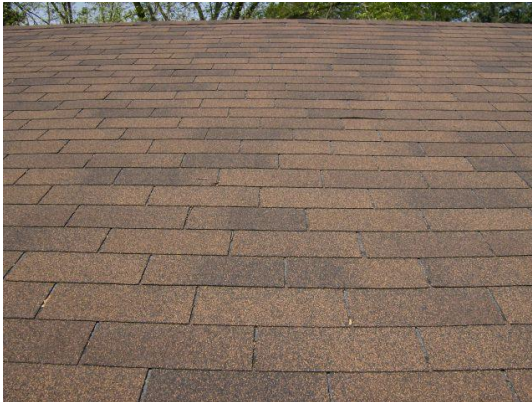
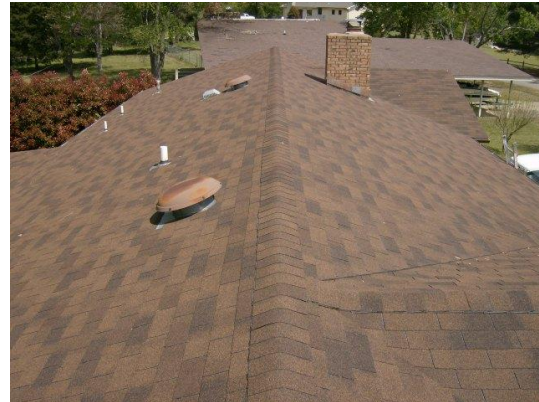
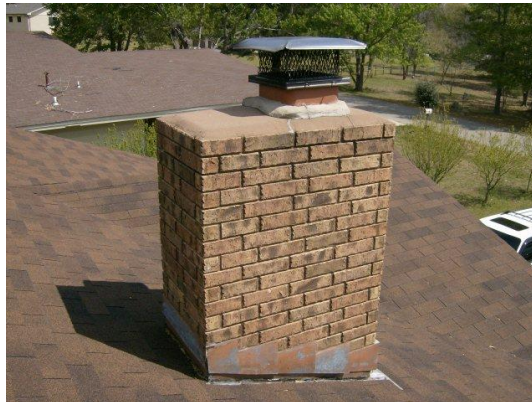
The roof coverings appear to be in generally good condition and may be less than one year old.

The chimney does not show signs of significant deterioration and roof flashing details appear to be in good order.

A drip edge flashing has been installed around the perimeter of the roof. This flashing also helps protect the roof sheathing from damage at the eave.

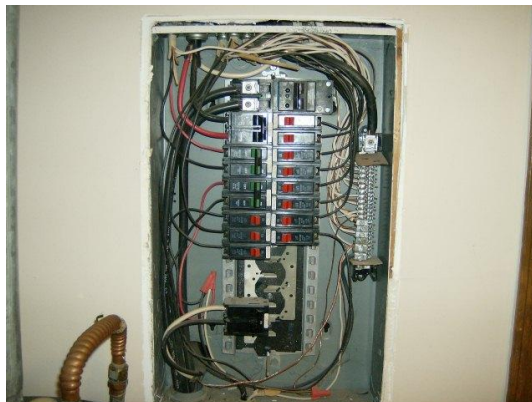
Main Electrical Panel

Inspection of the electrical system revealed the need for typical, minor repairs. Although these are not especially costly to repair, they should be a high priority for safety reasons. ***Unsafe electrical conditions represent a shock hazard.*** A licensed electrician should be consulted to undertake the repairs recommended below. Not all of the electrical circuits within the main panel were labeled.

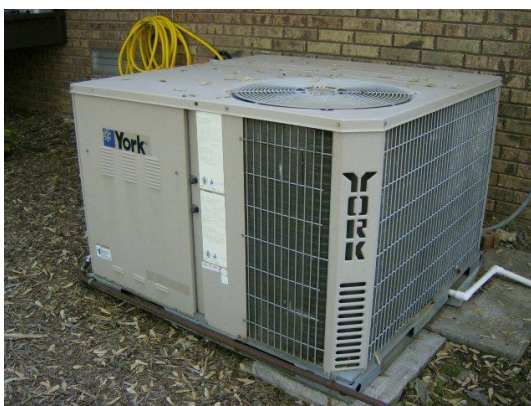
The capacity and configuration of the system should be sufficient for the home. Upon testing the air conditioning, a normal temperature drop (20 degrees) across the evaporator coil was observed. This suggests that the system is operating properly. The system responded properly to operating controls. The system shows no visible evidence of major defects.

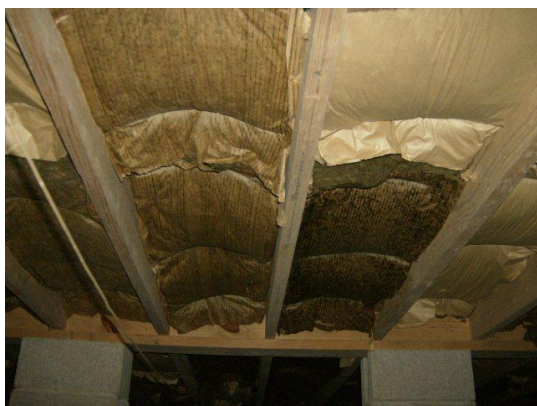
Floor Insulation

This appears to be a well insulated home.

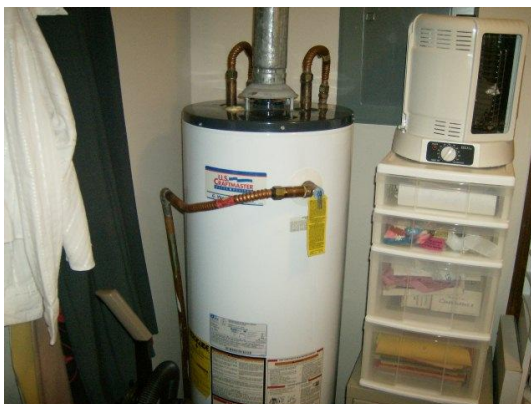
Gas Water Heater

The water heater is approximately 9 years old, appeared to be installed correctly and in good condition.
